#### GENERAL SUMMARY OF HULL DAMAGE

## DETAILED DESCRIPTION OF HULL DAMAGE

USS YO 180

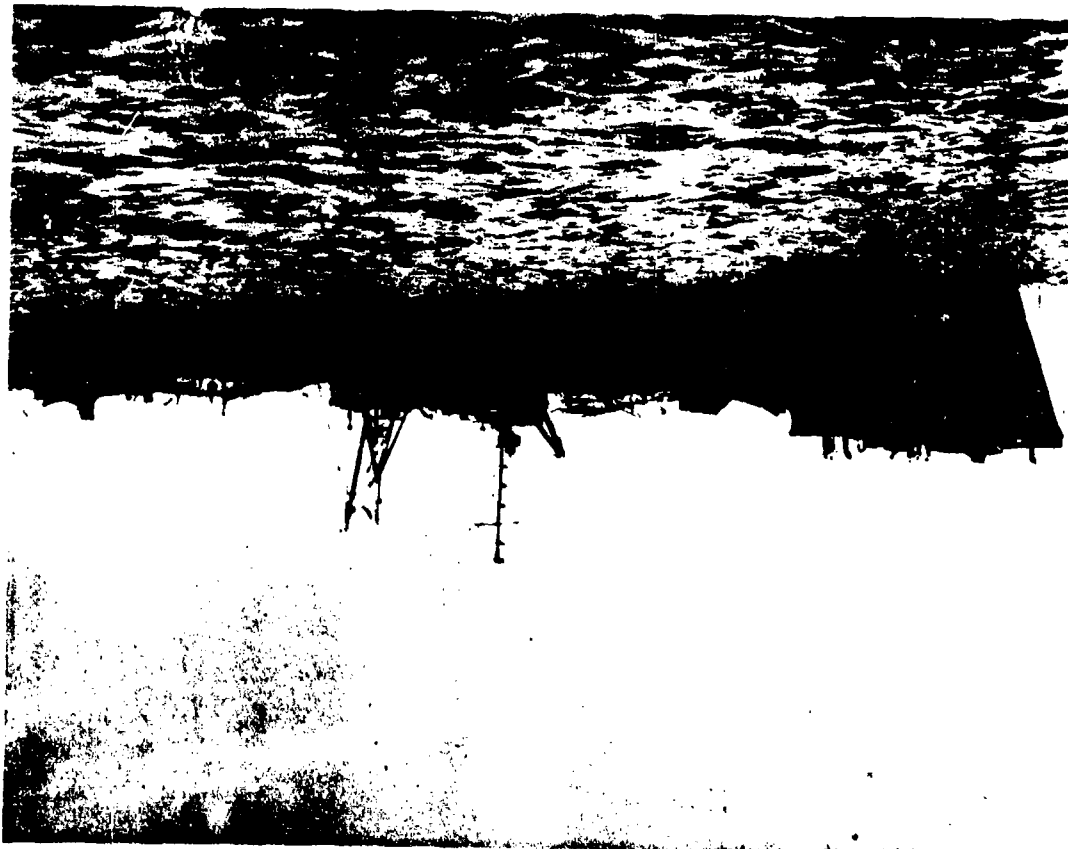
AA-CR-227-92-78. View from port bow after Test A.

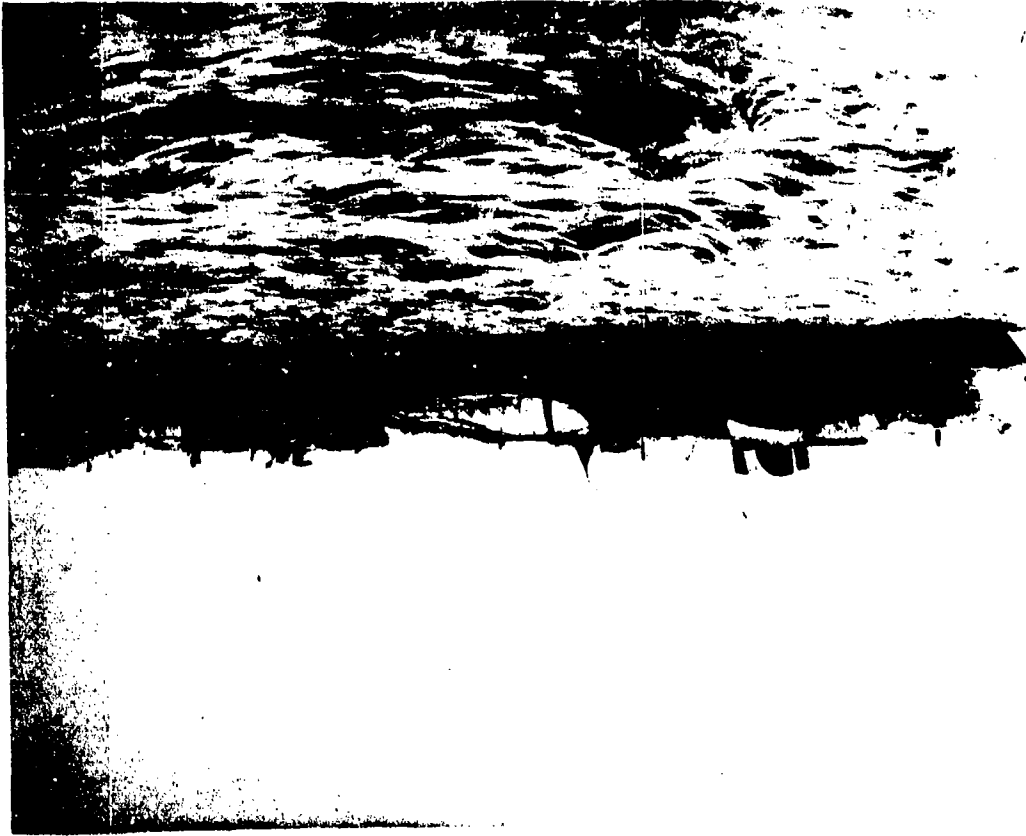
BB-CR-227-520-106. View from starboard quarter after Test A.

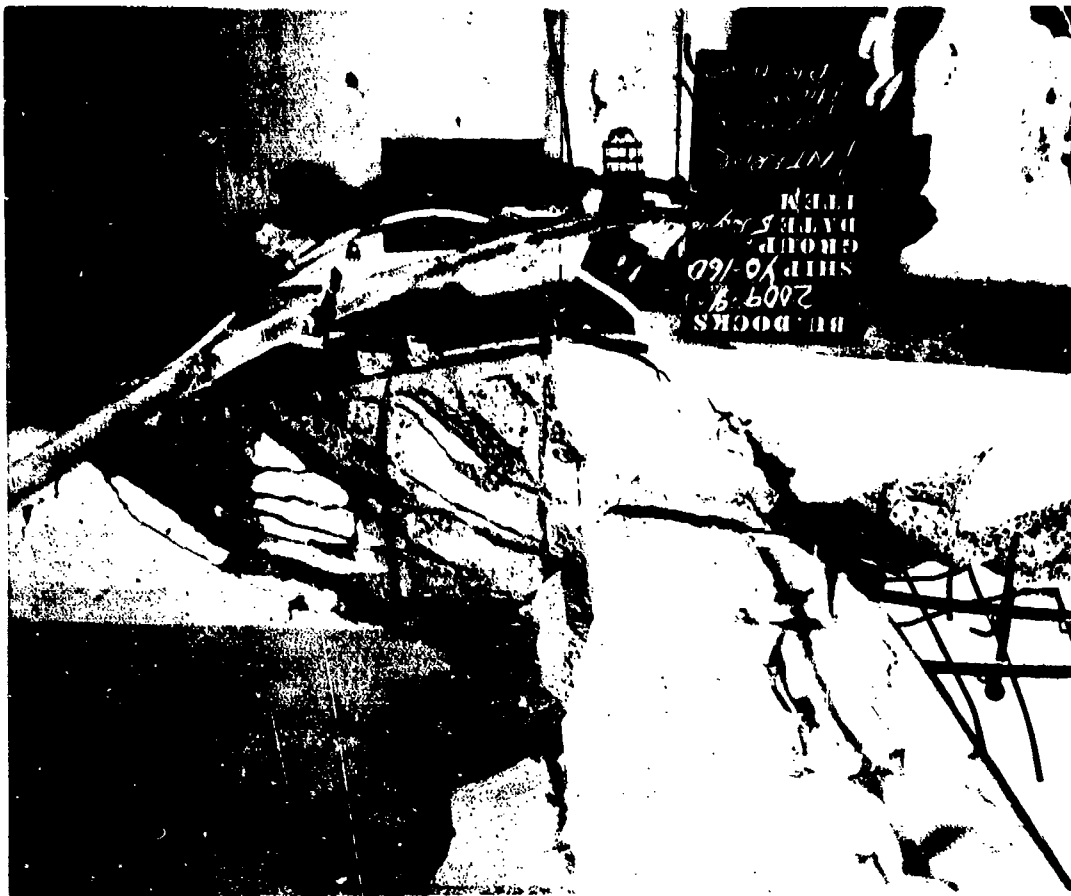
2. Midship deckhouse - the top structure of the forward, midship deck house is lying on the starboard side of the main deck (Photo 2007-5, page 61 ). The port, starboard and forward bulkheads on the main deck are almost undamaged (Photos 2007-10, 2008-5, pages 62, and 63 ). The after bulkhead is cracked and caved inward on the port side. The O1 deck has a hole where the previous structure was. The remaining deck beam at the forward edge of the hole is broken (Photo 2009-4 and 5, pages 64 and 65 ).

AA-CR-58-2009-4. Damage to overhead beams in forward midship deckhouse looking to port.

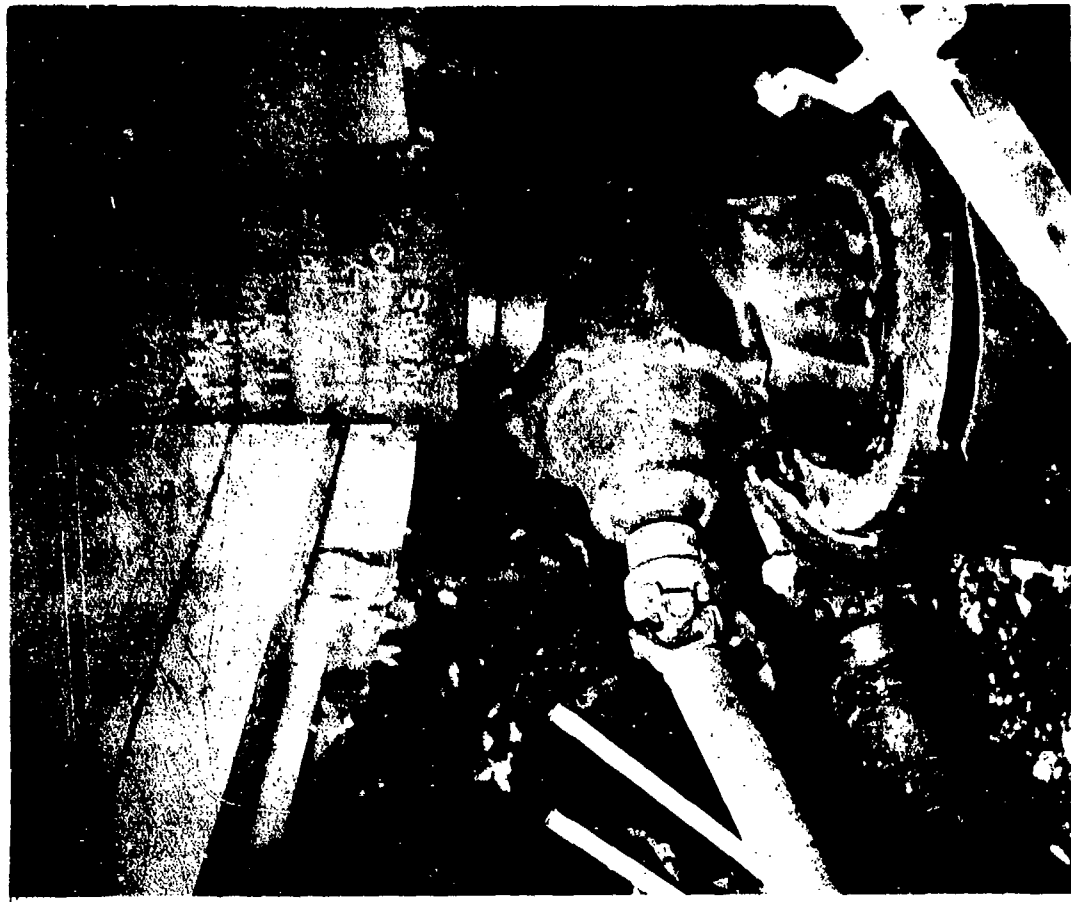
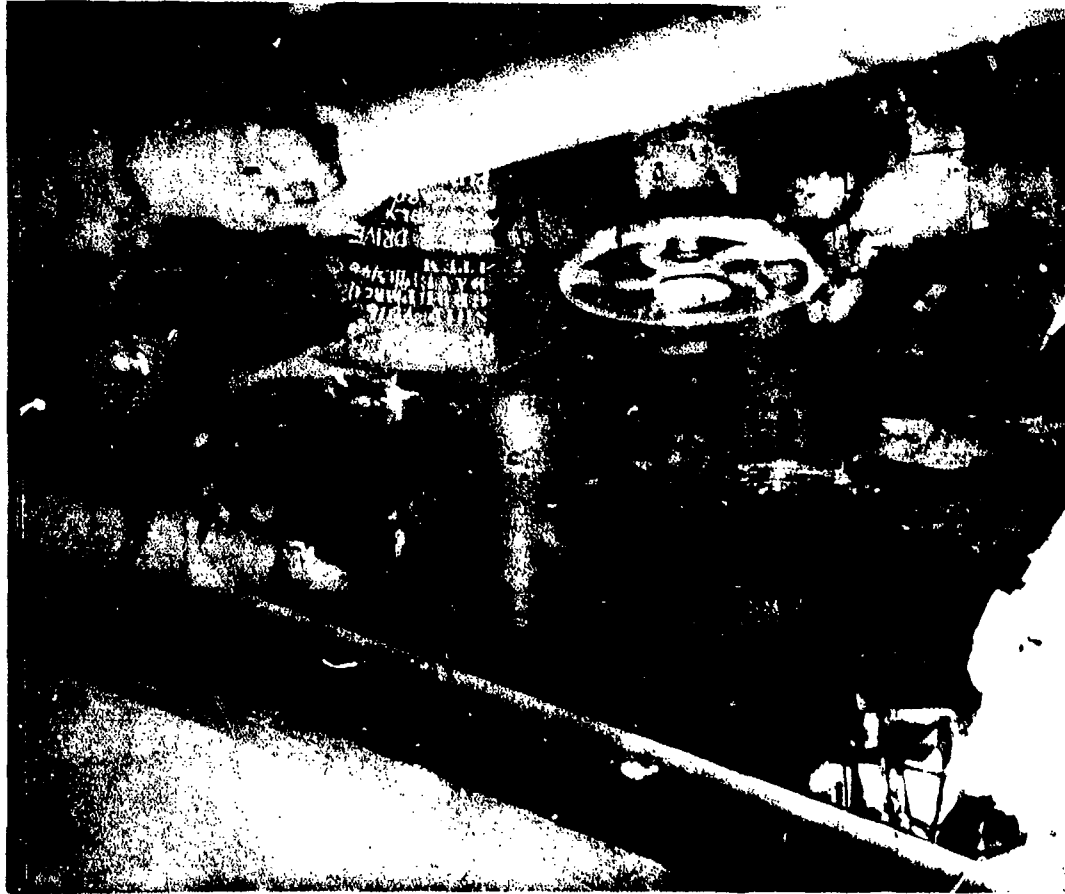
Equipment within the deck houses has been severely damaged by blast, by fire in the after superstructure, and by concrete or debris from falling structure. Pumping machinery in the midship deck house is out of commission (Photos 2161-1, 3, 2162-3, 4, pages 70, 71, 72, and 73). The steering engine can be operated by local control only. (Photo 2161-4, page 61). The ice machinery plant is inoperative.

All pumps damaged and inoperable (See photo 2161-1, 3, pages 70 and 71).

AA-CR-88-2161-1. Damage to upper drive assembly for cargo pumps and overhead structure of deck house amidship.

AA-CR-88-2161-3. Damage to upper drive assembly for cargo pumps and overhead structure of deck house amidship.

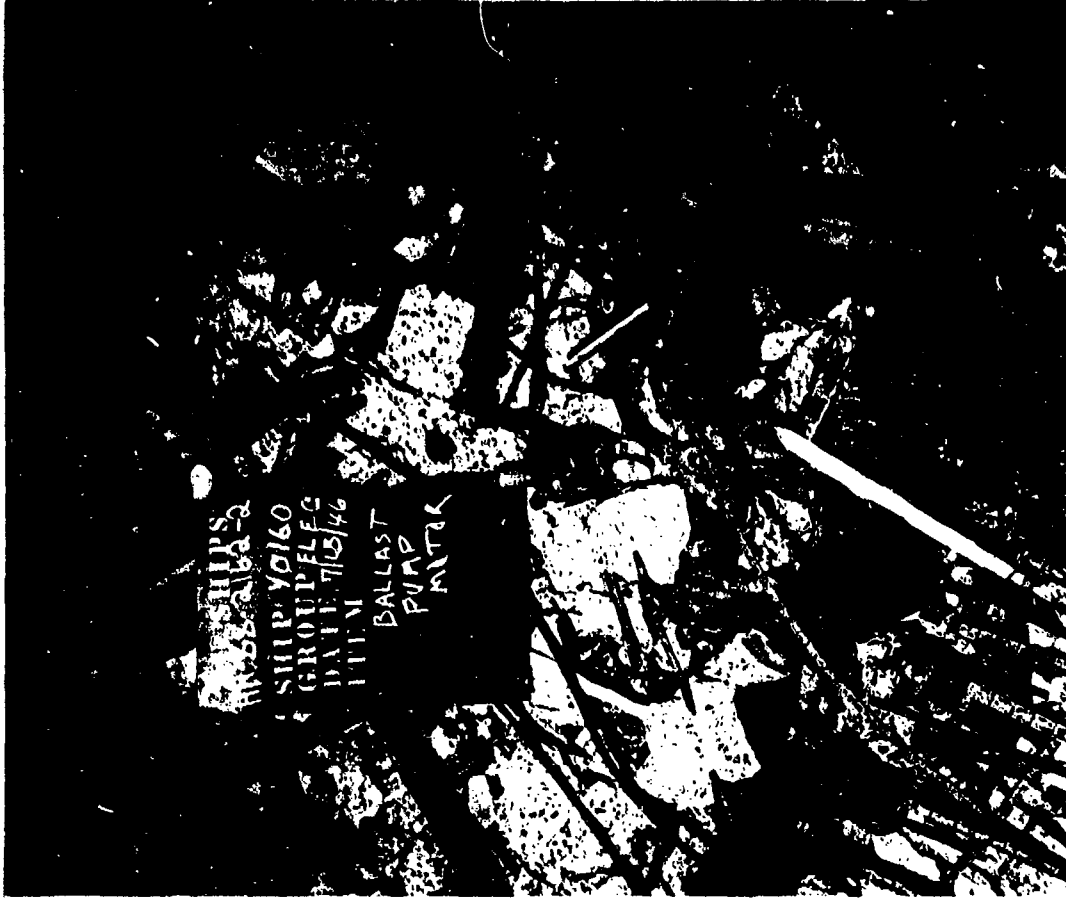
Compartments above the main deck are uninhabitable. Blast has wrecked structure and equipment. Falling debris has further damaged equipment and in the after superstructure fire did additional damage (Photos 2161-1, 3, 2162-3, 4, 2161-4, pages 70, 71, 72, 73 and 81).

AA-CR-88-2162-3. Interior of deckhouse amidship showing damaged ballast pump motor and rubble from demolished overhead.
